Manhole Inspection Summary

Manhole # S31MM1015MH

Insp Date: **3/26/07 2:18 PM**

Location Address: **4411 BEDFORD PL**

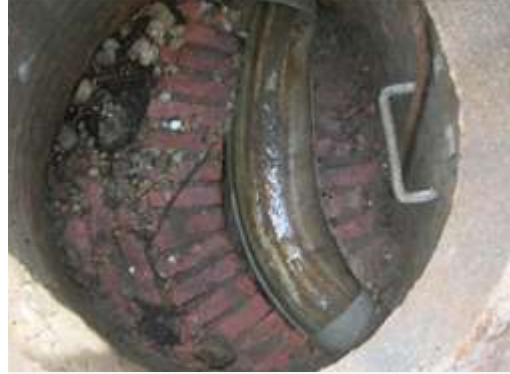
Top View

Bench ☒ Exists Material: **Brick** ☐ Parged ☒ **Debris** (not Condition related)

Bench debris.

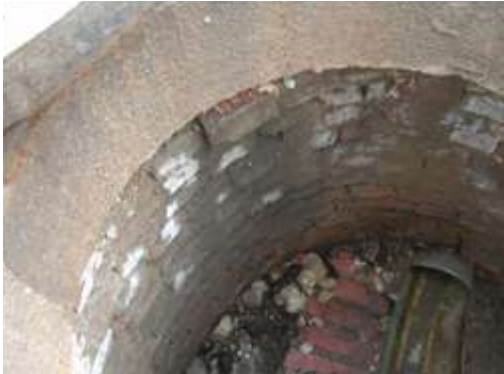
Defect

Condition: ☐ Sound ☐ Cracked ☐ Root Intrusion ☒ **Loose Brick** ☒ **Deteriorated**

Infiltration: ☐ None ☒ **Joint** ☐ Cracks ☐ Mortar ☐ Roots ☒ **Wall**

Condition: ☐ Sound ☐ Cracked ☐ Root Intrusion ☐ Loose Brick ☒ **Deteriorated**

Infiltration: ☐ None ☐ Joint ☐ Cracks ☒ **Mortar** ☐ Roots ☒ **Wall**

Corbel deterioration, loose brick and infiltration. Barrel infiltration.

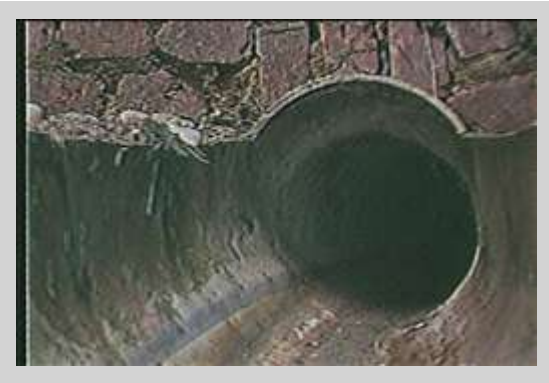
8 in. Circular Gravity Sewer Pipe Out @ 12 O'Clock

Barrel deterioration and infiltration.

Infiltration: **None** Pipe Seal Cond: **Cracked**

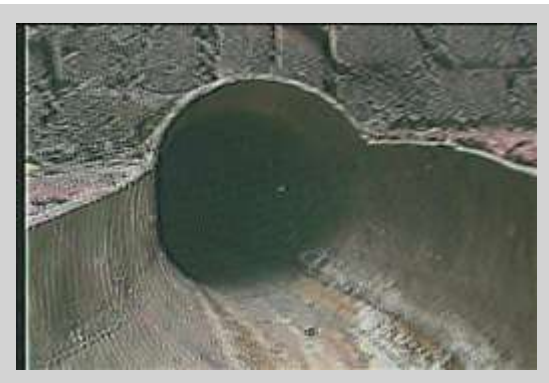
6 in. Circular Gravity Sewer Pipe In @ 3 O'Clock

Infiltration: **None** Pipe Seal Cond: **Unknown**
